## Kelsey Notch Trail Environmental Compliance Report 2025

## Overview of OHRV Trails in this report

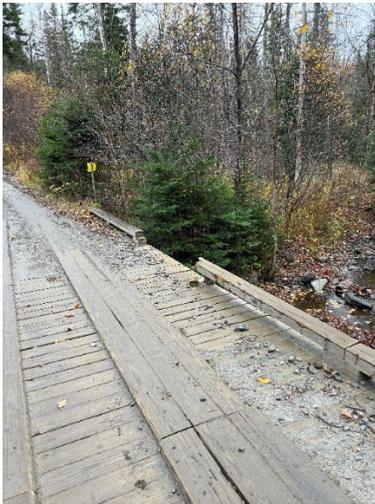
- *Make sure the ditches and culverts are cleaned out and there are no obstructions following large rain events like the one in July, 2024.*
- *Treat the australis phragmites and continue to monitor the invasive species so that it does not spread.*
- *Repair bridges that had broken railings (see photos below)*
- *Repair broken culverts from maintenance work.*

Figure 1- Depicts the broken bridge from 2024.

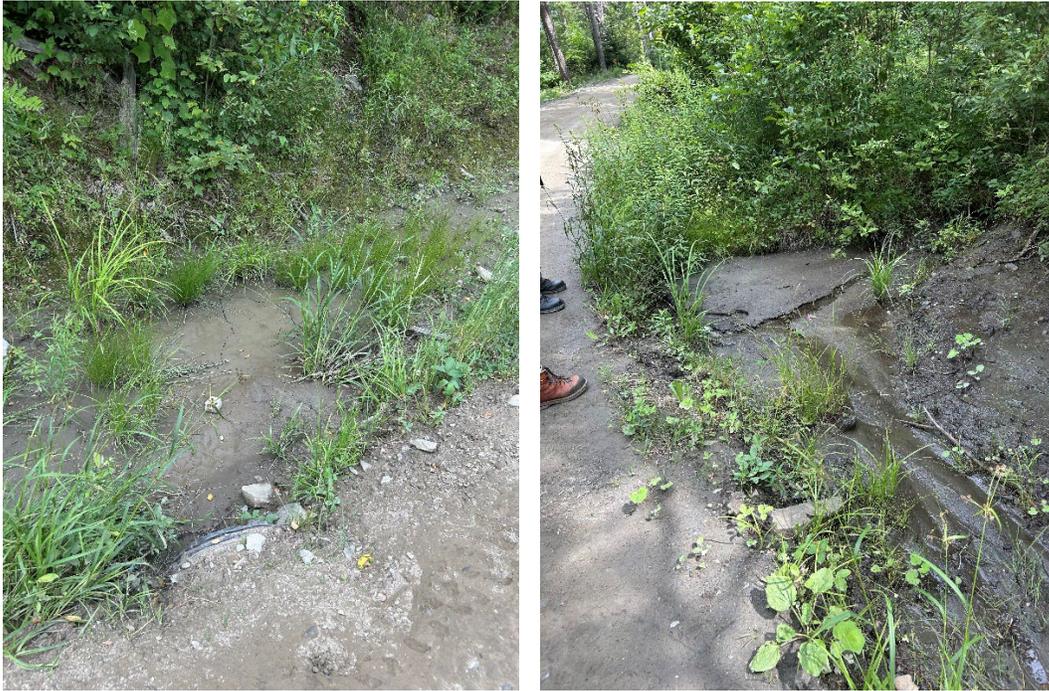
On **July 17, 2025** F&G, Trails Bureau and Forests and Lands went out for the first monitoring trip. The ditches and catch basins were filled with a significant amount of sediment signifying there was runoff that occurred, probably from the larger rain event around Memorial Day. The trail surface had mostly been repaired since that storm but there was still evidence from it.

*Figure 2 & 3 - Depicts filled ditch lines and sediment traps from runoff*

- Make sure the ditches and culverts are cleaned out and there are no obstructions following large rain events.
- Treat the australis phragmites and continue to monitor the invasive species so that it does not spread.
- Place straw waddles on the upslope side so that runoff does not go around waddle.

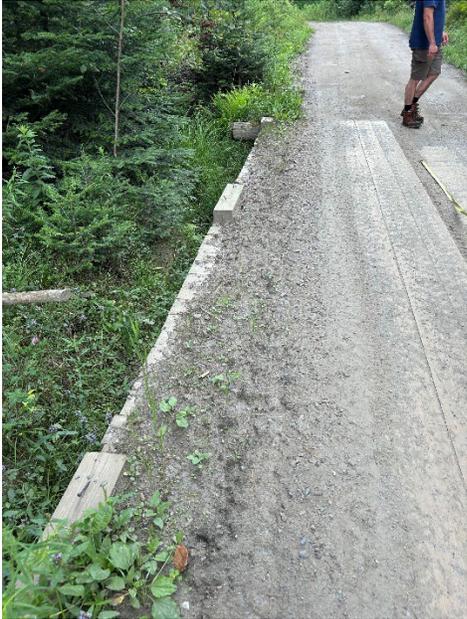
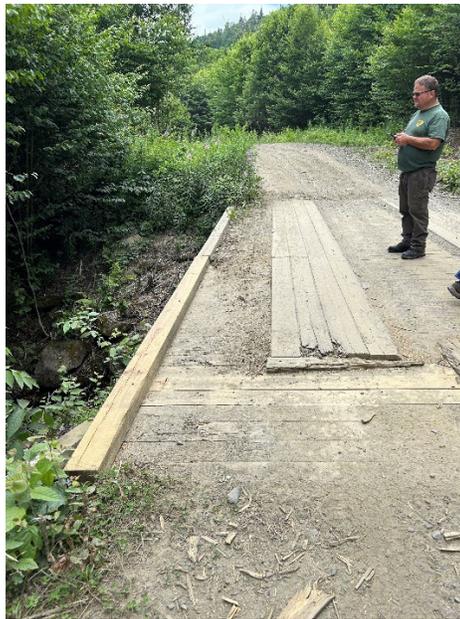
In 2024, it was noted that there were two bridges that had broken pieces on the edge where the “wheel curb” is located. None of these broken pieces affect the integrity or functionality of the bridge but should be fixed for safety reasons at some point. These had still not been fixed as of our July visit.

*Figure 4 & 5- Depicts sections of broken bridges that need repair*

Work Completed - In October, Trails Bureau staff did their annual maintenance which included grading, using rock crusher, rock raking and repairing some of the bridges that needed attention.

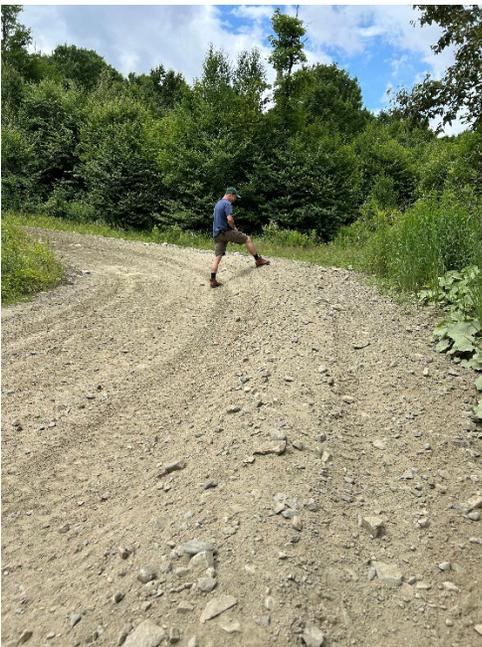
Overall, the surface of the trail was in good condition but there was significant work that occurred at the beginning of the season due to the rain event. There was a large berm that was evident on the sharp corner leading up into Kelsey Notch. (Figure 5)

*Figure 6- Depicts large berm on corner of trail*

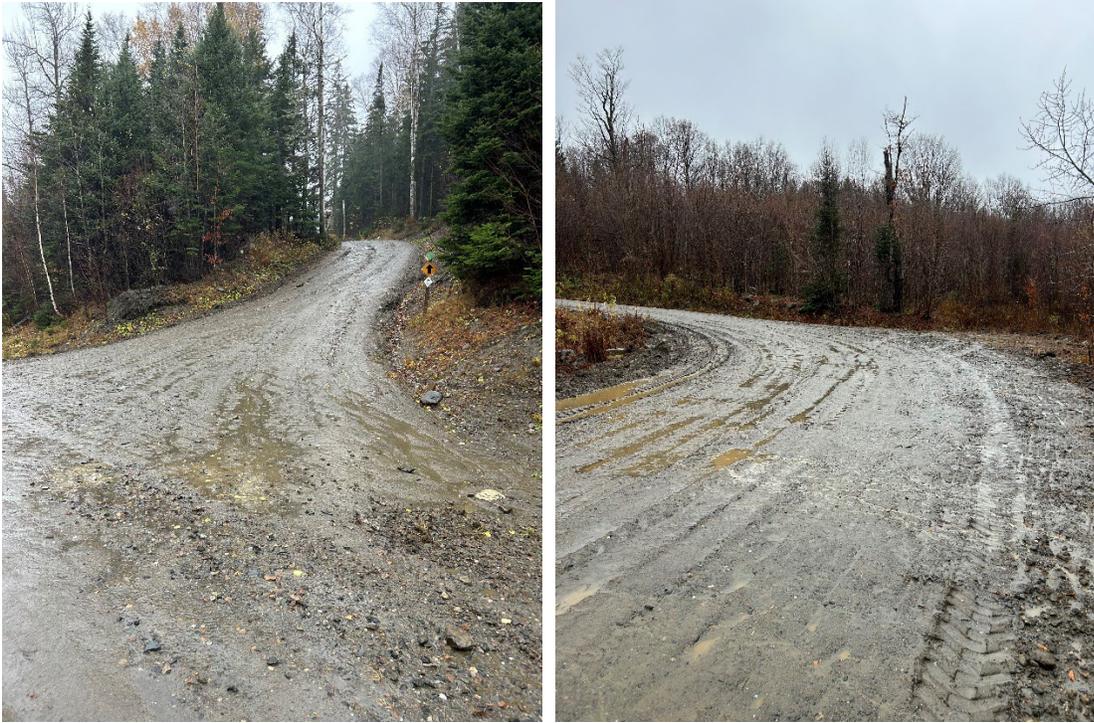
On **October 31, 2025**, the second monitoring trip took place. The trail had just had its yearly maintenance so the trail was in pretty good shape despite it raining that day.

*Figure 7 & 8- Shows the condition of the trail surface*

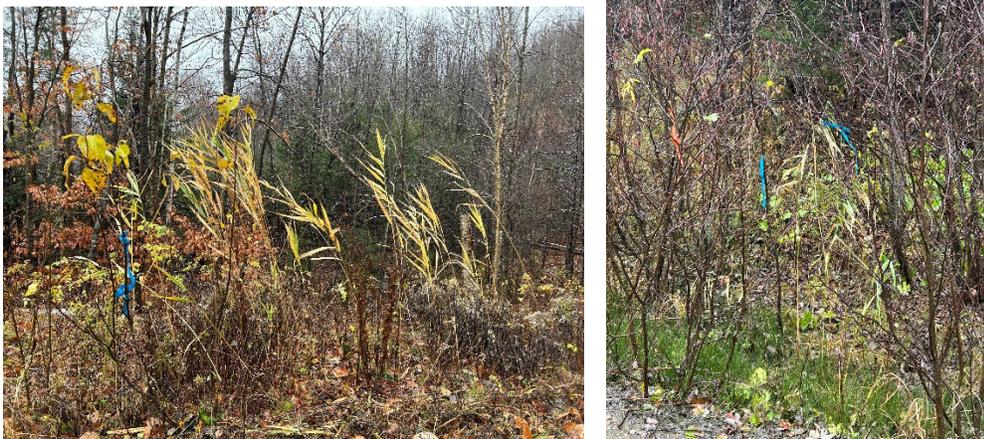
In 2020, *Phragmites australis* was found onsite. These areas were treated on September 3, 2021, with glyphosate by Fish and Game staff who are licensed pesticide applicators. During our 2022 visit no plants were found., However in 2023 a new site was located. This will continue to be monitored by Forests and Lands and Fish and Game staff. The *phragmites australis* was not treated in 2024 or 2025 but continues to be documented. Currently, there is no one on staff who is certified to treat invasives out of the North Region office.

*Figure 9 & 10- Shows picture of phragmites that was found during the monitoring trip.*

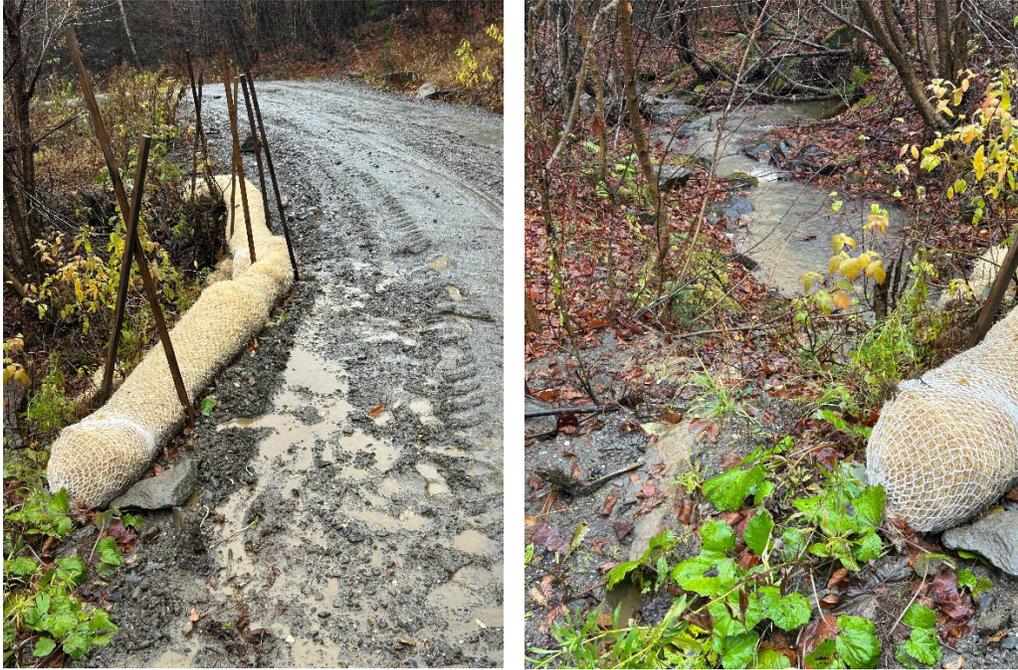
*Figure 11 & 12- Depicts straw waddle added after the trail maintenance work to minimize erosion.*

A recommendation of the 2023 report was to add additional erosion control devices around one of the larger culverts that has water running continuously. The Trails Bureau continues to add straw waddles, however, the waddles that were added in 2025 weren't catching the runoff, making them not as effective.

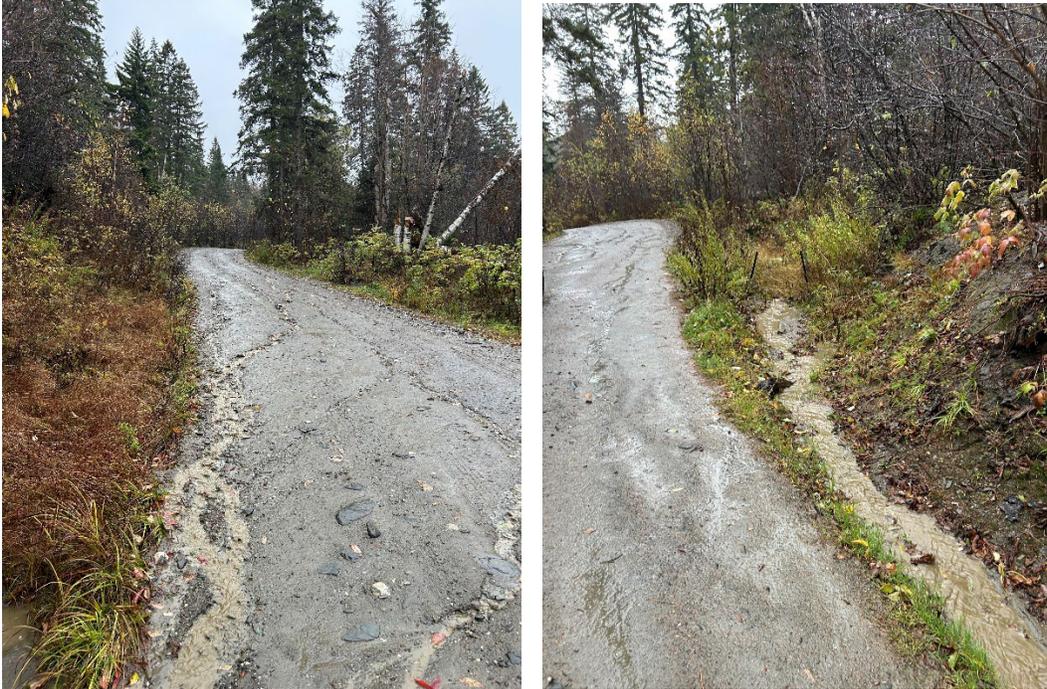
There continues to be runoff and sedimentation during rain events. Typically the sediment is being collected in the ditches and catch basins but sometimes it does get into the smaller streams.

*Figure 13 & 14- Depicts the runoff that occurs during rain events.*

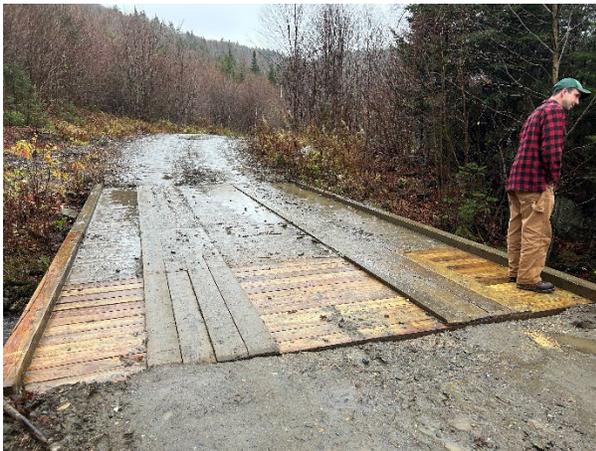
*Figure 15- Depicts the repairs that were made to the bridge.*
